PROYECTO FINAL DE CARRERA

Patología estructural y del casco:

Métodos de protección, inspección, mantenimiento y reparación

Ingeniería Naval y Oceánica
Junio, 2014

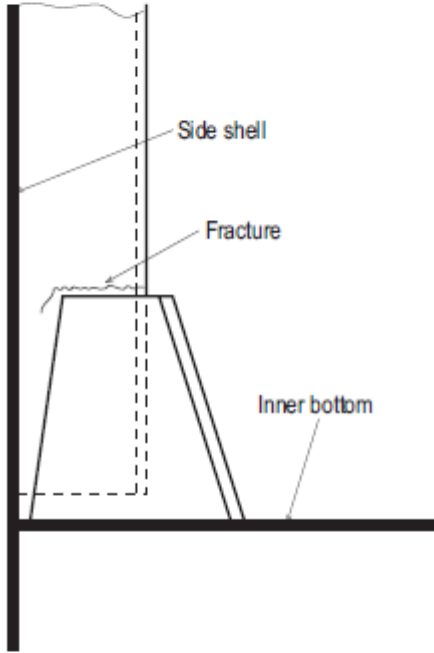
CONTAINER SHIPS		Guidelines for Surveys, Assessment and Repair of Hull Structures	
PART 1	Cargo hold region	EXAMPLE No.	
AREA 2	Side structure including tanks	1	
Detail of damage		Fracture in side shell frame at lower bracket	
<p>Sketch of damage</p>

<p>Notes on possible cause of damage</p> <p>1. This type of damage is caused due to stress concentration.</p>		<p>Notes on repairs</p> <ol style="list-style-type: none"> 1. For small fractures, e.g. hairline fractures, the fracture can be veed-out, welded up, ground, examined by NDT for fractures, and rewelded. 2. For larger / significant fractures consideration is to be given to cropping and partly renewing / renewing the frame brackets. If renewing the brackets, end of frames can be sniped to soften them. 3. If considered necessary soft toes may be incorporated at the boundaries of the bracket to the inner bottom plating.

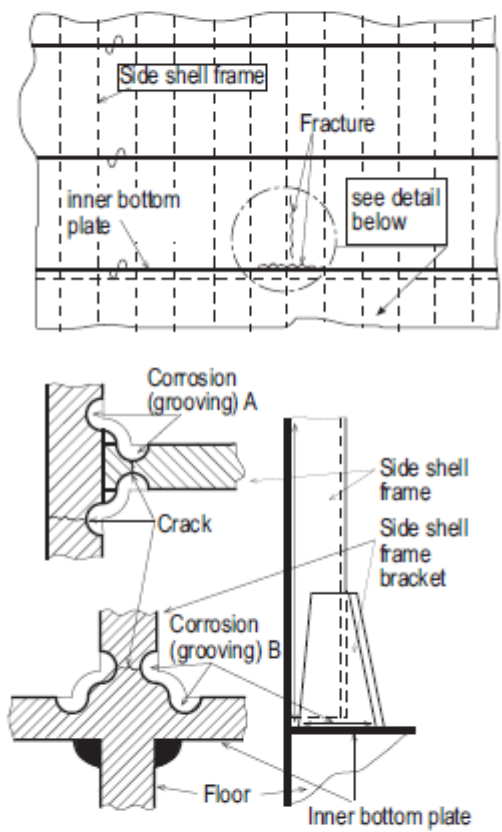
CONTAINER SHIPS		Guidelines for Surveys, Assessment and Repair of Hull Structures	
PART 1	Cargo hold region		EXAMPLE No.
AREA 2	Side structure including tanks		2-a
Detail of damage		Fractures in side shell frame/lower bracket and side shell plating near tank top	
<p>Sketch of damage</p>

<p>Part renewal including side shell frames and inner bottom plating, as found necessary</p>	
<p>Notes on possible cause of damage</p> <ol style="list-style-type: none"> 1. Fracture in side shell plating along side shell frame: Heavy corrosion (grooving) along side shell frame (See A) 2. Fracture in side shell plating along tank top: Heavy corrosion (grooving) along tank top (See B) resulting in detachment of side shell frame bracket from inner bottom plating. 		<p>Notes on repairs</p> <ol style="list-style-type: none"> 1. Sketch of repair applies when damage extends over several frames. 2. Isolated fractures may be repaired by veeing-out and rewelding. 3. Isolated cases of grooving may be repaired by build up of welding.

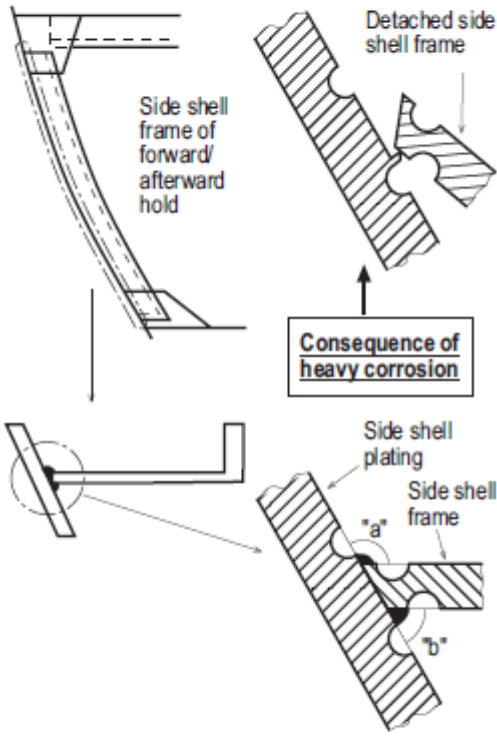
CONTAINER SHIPS		Guidelines for Surveys, Assessment and Repair of Hull Structures	
PART 1	Cargo hold region		EXAMPLE No.
AREA 2	Side structure including tanks		2-b
Detail of damage		Adverse effect of corrosion on the frame of forward/afterward hold	
<p>Sketch of damage</p>

<ol style="list-style-type: none"> 1. Part renewal including side shell frames and inner bottom plating, as found necessary. 2. Deep penetration welding at the connections of side shell frame to side shell plating 	
<p>Notes on possible cause of damage</p> <p>1. Heavy corrosion (grooving) of side shell frame along side shell plating and difference of throat thickness "a" from "b". (Since original throat thickness of "a" is usually smaller than that of "b", if same welding procedure is applied, the same corrosion has a more severe effect on "a", and may cause collapse and / or detachment of side shell frame.)</p>		<p>Notes on repairs</p> <ol style="list-style-type: none"> 1. Sketch of repair applies when damage extends over several frames. 2. Isolated fractures may be repaired by veeing-out and rewelding. 3. Isolated cases of grooving may be repaired by build up of welding.

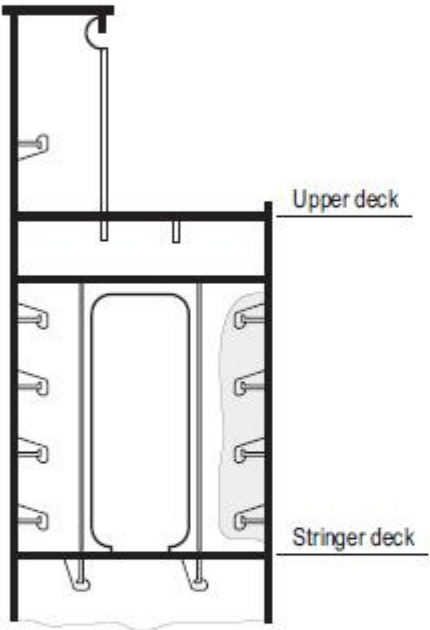
CONTAINER SHIPS		Guidelines for Surveys, Assessment and Repair of Hull Structures	
PART 1	Cargo hold region		EXAMPLE No.
AREA 2	Side structure including tanks		3-a
Detail of damage		Buckling of side structure in way of side tank/passage way	
Sketch of damage

Notes on possible cause of damage 1. Deformation of web of transverse web frame and / or distortion of side longitudinals due to insufficient buckling strength. 2. Insufficient strengthening of side structure in way of tug and / or fender area or misplacing of strengthened area, respectively.		Notes on repairs 1. Straightening or renewal (if necessary) of buckled web plate and distorted side longitudinals. 2. Fitting of additional horizontal stiffeners on web plate in way of side longitudinals. 3. Strengthening of tug or fender area or shifting of affected area to right position should be considered.

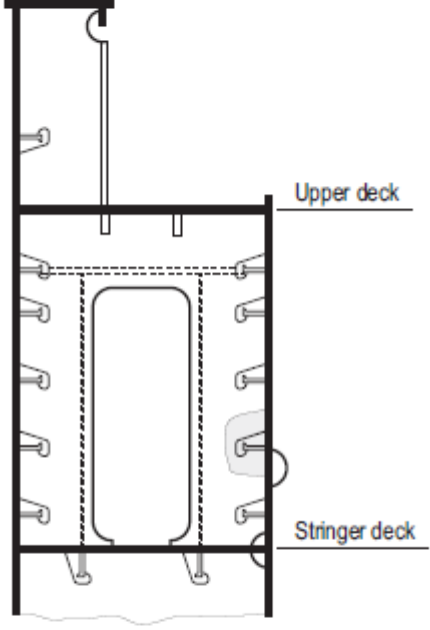
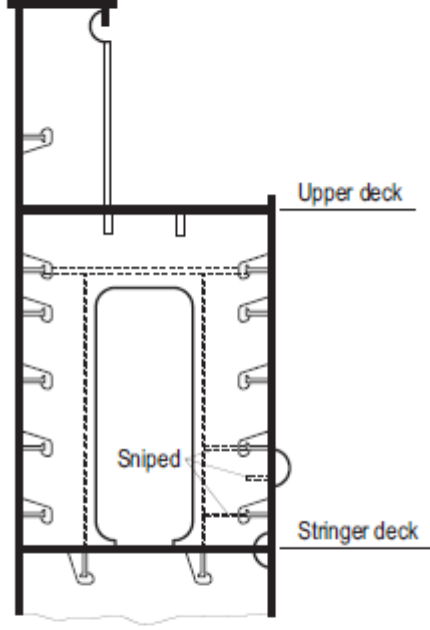
CONTAINER SHIPS		Guidelines for Surveys, Assessment and Repair of Hull Structures	
PART 1	Cargo hold region		EXAMPLE No.
AREA 2	Side structure including tanks		3-b
Detail of damage		Buckling of side structure in way of fender	
Sketch of damage		Sketch of repair

Notes on possible cause of damage 1. Buckling of web of transverse web frame due to insufficient buckling strength in way of fender.		Notes on repairs 1. Straightening or renewal (if necessary) of buckled web plate and closing of cut-out for side longitudinal. 2. Fitting of additional horizontal stiffeners on web plate in way of fender.

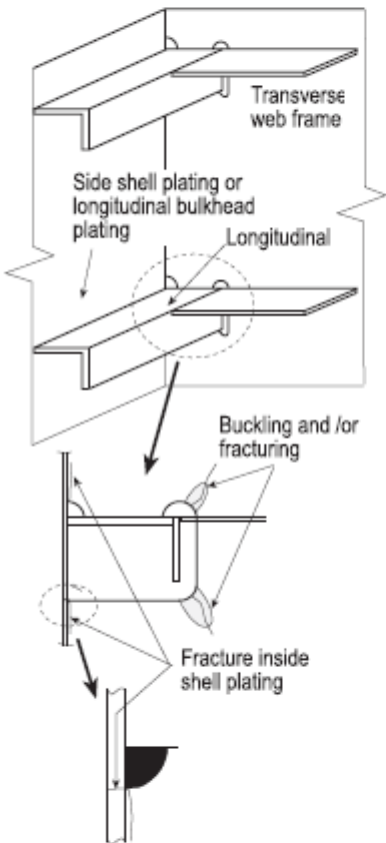
CONTAINER SHIPS		Guidelines for Surveys, Assessment and Repair of Hull Structures	
PART 1	Cargo hold region		EXAMPLE No.
AREA 2	Side structure including tanks		4-a
Detail of damage		Fractures and buckling in way of a cut-out for the passage of a longitudinal through a transverse web	
<p>Sketch of damage</p>

<p>Notes on possible cause of damage</p> <p>1. Damage can be caused by general levels of corrosion and presence of stress concentration associated with the presence of a cut-out.</p>		<p>Notes on repairs</p> <p>1. If fractures are significant then crop and part renew the web plating otherwise the fracture can be veed-out and welded provided the plating is not generally corroded.</p> <p>2. Repair B is to be incorporated if the lug proves to be ineffective.</p>

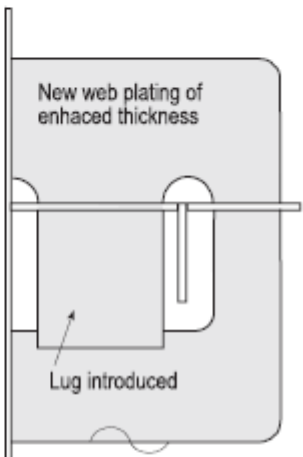
<p>Sketch of repair</p> <p>Repair A</p>

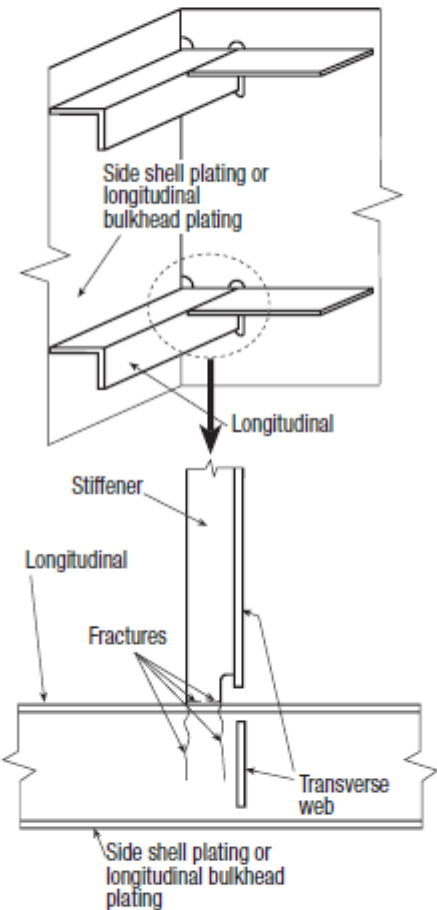
CONTAINER SHIPS		Guidelines for Surveys, Assessment and Repair of Hull Structures	
PART 1	Cargo hold region		EXAMPLE No.
AREA 2	Side structure including tanks		4-b
Detail of damage		Fractures at the connection of side shell longitudinal to transverse web	
<p>Sketch of damage</p>

<p>Side shell plating or longitudinal bulkhead plating</p> <p>Longitudinal</p> <p>Stiffener</p> <p>Fractures</p> <p>Transverse web</p> <p>Side shell plating or longitudinal bulkhead plating</p>		<p>Sketch of repair</p>

<p>Notes on possible cause of damage</p> <ol style="list-style-type: none"> 1. Damage can be caused by stress concentrations leading to accelerated fatigue in this region. 		<p>Notes on repairs</p> <ol style="list-style-type: none"> 1. If fracture extends to over one third of the depth of the longitudinal, then crop and part renew. Otherwise the fracture can be veed-out and welded.

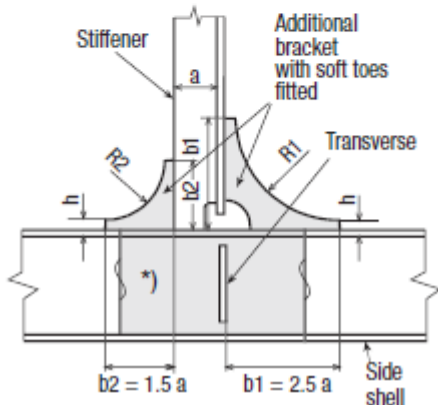
<p>Stiffener</p> <p>Additional bracket with soft toes fitted</p> <p>Transverse</p> <p>Side shell</p> <p>$b_2 = 1.5 a$</p> <p>$b_1 = 2.5 a$</p> <p>*) Where required, the longitudinal to be cropped and part renewed</p> <ol style="list-style-type: none"> 1. For a slope at toes max. 1:3, $R_1 = (b_1 - h) \times 1.6$ and $R_2 = (b_2 - h) \times 1.6$ 2. Soft toe bracket to be welded first to longitudinal 3. Scallop in bracket to be as small as possible recommended max. 35mm 4. If toes of brackets are ground smooth, full penetration welds in way to be provided 5. Maximum length to thickness ratio = 50:1 for unstiffened bracket edge 6. Toe height, h, to be as small as possible (10-15 mm)

<p>Note: Regarding detail of brackets see 4-b</p>	
<p>Notes on possible cause of damage</p> <p>1. Damage can be caused by stress concentrations leading to accelerated fatigue in this region.</p>		<p>Notes on repairs</p> <p>1. If fracture extends to over one third of the depth of the longitudinal, then crop and part renew. Otherwise the fracture can be veed-out and welded.</p>

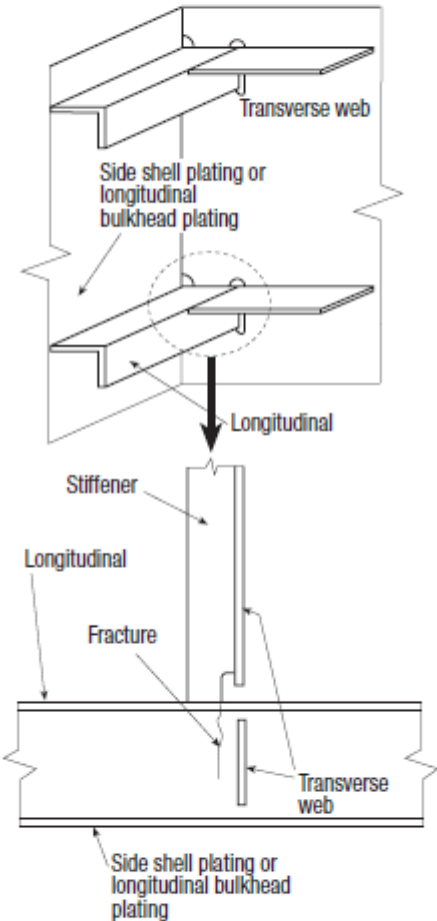
CONTAINER SHIPS		Guidelines for Surveys, Assessment and Repair of Hull Structures	
PART 1	Cargo hold region	EXAMPLE No.	
AREA 2	Side structure including tanks	4-c	
Detail of damage		Fractures at the connection of side shell longitudinal to transverse web	
<p>Sketch of damage</p>

<p>*) Where required, the longitudinal to be cropped and part renewed</p> <p>Various cut-out shapes have been developed.</p> <p>The following is one example:</p> <ol style="list-style-type: none"> 1. Toe height as small as possible (h= 10-15 mm) 2. Depth "d" of key hole notch as small as possible, max. 30 mm 3. For a slope at toe max. 1:3, $R1 = 1.5 d$; $R2 = d$ and $R3 = 1.5 c$ 	
<p>Notes on possible cause of damage</p> <ol style="list-style-type: none"> 1. Damage can be caused by stress concentrations leading to accelerated fatigue in this region. 		<p>Notes on repairs</p> <ol style="list-style-type: none"> 1. If fracture extends to over one third of the depth of the longitudinal, then crop and part renew. Otherwise the fracture can be veed-out and welded.

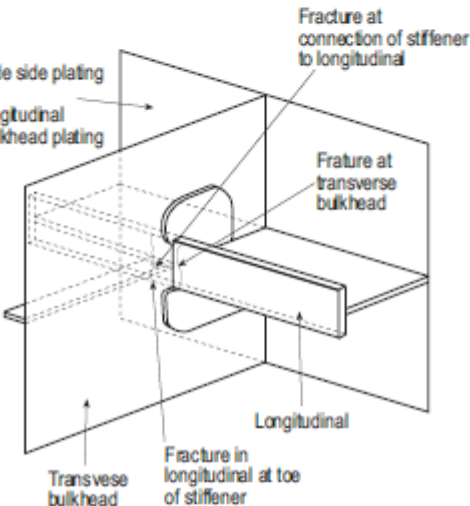
CONTAINER SHIPS		Guidelines for Surveys, Assessment and Repair of Hull Structures	
PART 1	Cargo hold region		EXAMPLE No.
AREA 2	Side structure including tanks		4-d
Detail of damage		Fractures at the connection of side shell longitudinal to transverse bulkhead	
<p>Sketch of damage</p>

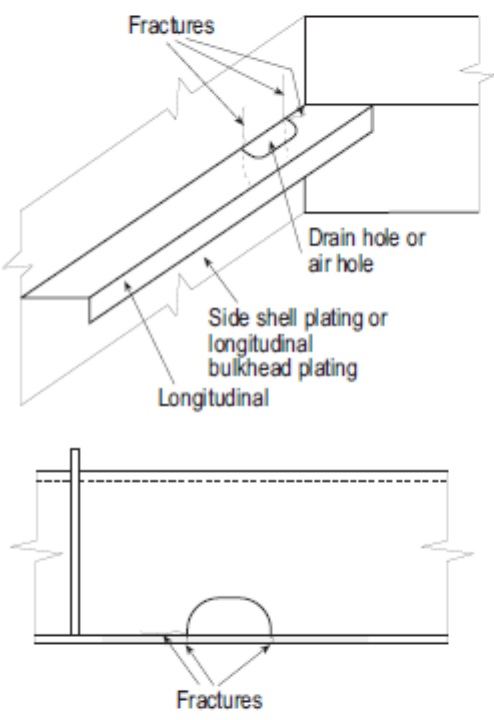
CONTAINER SHIPS		Guidelines for Surveys, Assessment and Repair of Hull Structures	
PART 1	Cargo hold region		EXAMPLE No.
AREA 2	Side structure including tanks		5
Detail of damage		Fractures in side shell plating/longitudinal bulkhead plating at the corner of the drain hole in longitudinal	
<p>Sketch of damage</p>

<p>Notes on possible cause of damage</p> <p>1. Stress concentration and/or corrosion due to stress concentration at the corner of drain hole/air hole.</p>		<p>Notes on repairs</p> <p>1. Fractured plating should be cropped and part renewed. If fatigue life is to be improved, change of drain hole/air hole shape is to be considered.</p>

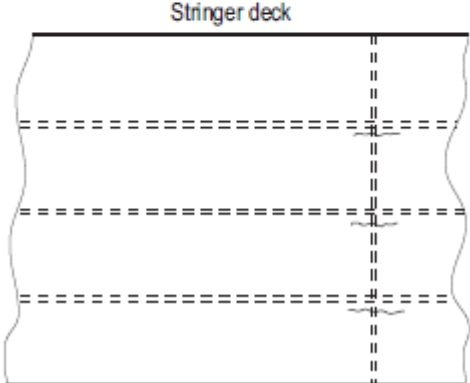
CONTAINER SHIPS		Guidelines for Surveys, Assessment and Repair of Hull Structures	
PART 1	Cargo hold region		EXAMPLE No.
AREA 2	Side structure including tanks		6
Detail of damage		Fractures in side wall (raised tank) at the connection of longitudinals to web of transverses	
<p>Sketch of damage</p>

<p>Notes on possible cause of damage</p> <p>1. Damage can be caused by stress concentration leading to accelerated fatigue in this region.</p>		<p>Notes on repairs</p> <p>1. Fractured side wall plating to be cropped and renewed by insert plate.</p> <p>2. Cut-outs for longitudinals to be closed by collar plates.</p>

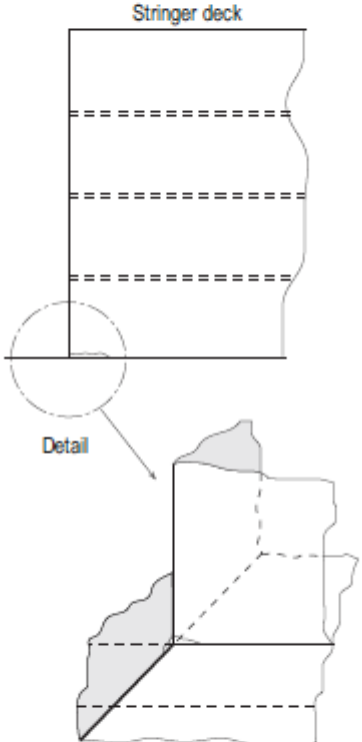
CONTAINER SHIPS		Guidelines for Surveys, Assessment and Repair of Hull Structures	
PART 1	Cargo hold region	EXAMPLE No.	
AREA 2	Side structure including tanks	7	
Detail of damage		Fractures at the termination of stringer deck (raised tank)	
<p>Sketch of damage</p>

<p>Notes on possible cause of damage</p> <ol style="list-style-type: none"> 1. Damage can be caused by stress concentration leading to fatigue in this region. 		<p>Notes on repairs</p> <ol style="list-style-type: none"> 1. Fracture in tank top plating to be cropped and renewed by insert. 2. Repair A: Small brackets should be provided at the termination in longitudinal and / or transverse direction (proposed length about 100 mm) 3. Repair B: Modification of the design with soft nose transition should be considered.

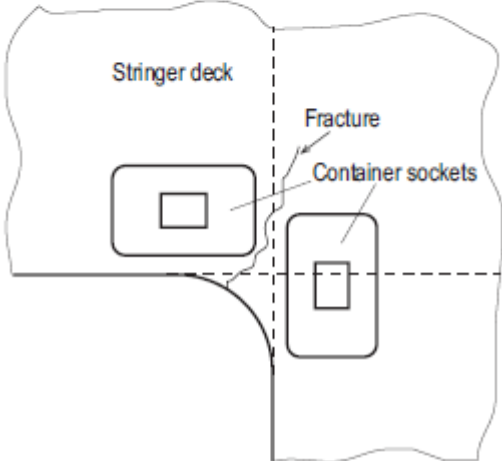
CONTAINER SHIPS		Guidelines for Surveys, Assessment and Repair of Hull Structures	
PART 1	Cargo hold region		EXAMPLE No.
AREA 2	Side structure including tanks		8
Detail of damage		Fracture in stringer deck in way of container sockets	
<p>Sketch of damage</p>

<p>Notes on possible cause of damage</p> <ol style="list-style-type: none"> 1. Stress concentration in the radiused corner in combination with stress concentration due to the arrangement of two separate container sockets. 2. Missing or insufficient support by internal structure in way of the container sockets. 		<p>Notes on repairs</p> <ol style="list-style-type: none"> 1. Fractured plating of stringer deck to be cropped and renewed by insert. 2. Use of a combined container socket instead of two separate sockets. 3. Additional internal stiffening structure should be considered, if necessary

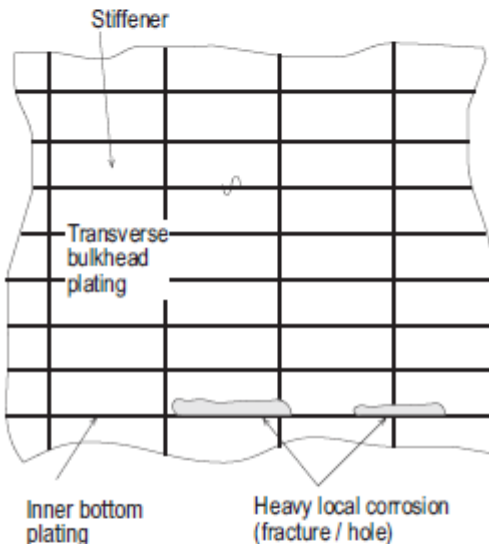
CONTAINER SHIPS		Guidelines for Surveys, Assessment and Repair of Hull Structures	
PART 1	Cargo hold region		EXAMPLE No.
AREA 3	Transverse bulkhead structure		1
Detail of damage		Corrosion along inner bottom plating	
<p>Sketch of damage</p>

<p>Notes on possible cause of damage</p> <p>1. Heavy corrosion including grooving along inner bottom.</p>		<p>Notes on repairs</p> <p>1. The extent of the renewal should be determined carefully. If the renewal plate (original thickness) is welded to thin plate (corroded plate), it may cause stress concentration and cause fracture.</p> <p>2. Protective coating should be applied.</p>

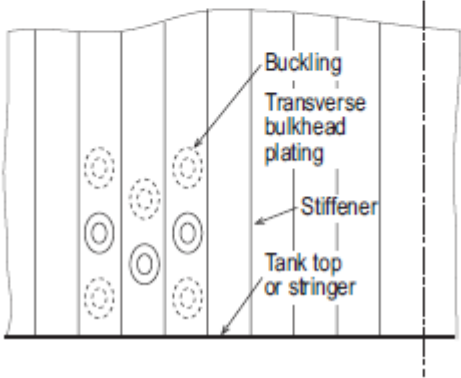
CONTAINER SHIPS		Guidelines for Surveys, Assessment and Repair of Hull Structures	
PART 1	Cargo hold region		EXAMPLE No.
AREA 3	Transverse bulkhead structure		2
Detail of damage		Buckling in transverse bulkhead	
<p>Sketch of damage</p>

<p>Notes on possible cause of damage</p> <p>1. Heavy general corrosion.</p>		<p>Notes on repairs</p> <p>1. The extent of the renewal should be determined carefully. If the renewal plating (original thickness) is welded to thin plating (corroded plating), it may cause stress concentration and fracture.</p> <p>2. Protective coating should be applied.</p>

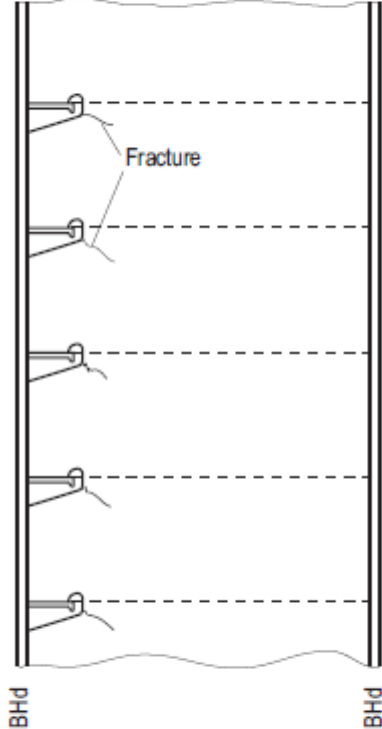
CONTAINER SHIPS		Guidelines for Surveys, Assessment and Repair of Hull Structures	
PART 1	Cargo hold region		EXAMPLE No.
AREA 3	Transverse bulkhead structure		3
Detail of damage		Fractures in cut-outs for vertical stiffeners	
<p>Sketch of damage</p>

<p>Notes on possible cause of damage</p> <p>1. Damage caused by stress concentration leading to fatigue fractures.</p>		<p>Notes on repairs</p> <p>1. The fractured plating is to be cropped and part renewed as necessary.</p> <p>2. Collar plates to cut-outs are to be installed.</p>

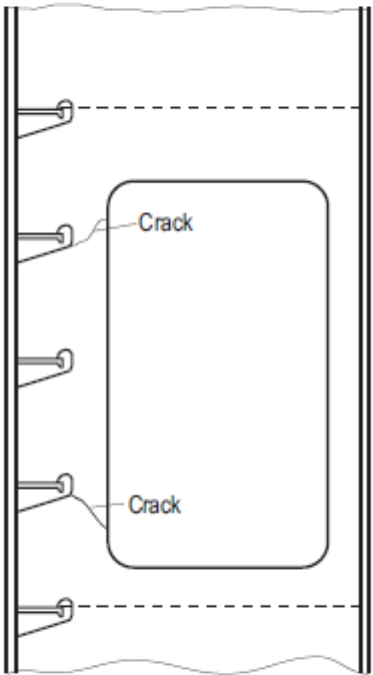
CONTAINER SHIPS		Guidelines for Surveys, Assessment and Repair of Hull Structures	
PART 1	Cargo hold region		EXAMPLE No.
AREA 3	Transverse bulkhead structure		4
Detail of damage		Fractures at the corners of access cut-outs	
<p>Sketch of damage</p>

<p>Notes on possible cause of damage</p> <p>1. Damages caused by stress concentration leading to fatigue fractures.</p>		<p>Notes on repairs</p> <p>1. Insertion of plating of increased thickness (chamfer 1:3 to 1:5).</p> <p>2. Collar plates to cut-outs for vertical stiffeners are to be installed.</p> <p>3. Additional stiffener adjacent to access opening to be fitted</p> <p>4. Reduction in size of access hole to be considered.</p>

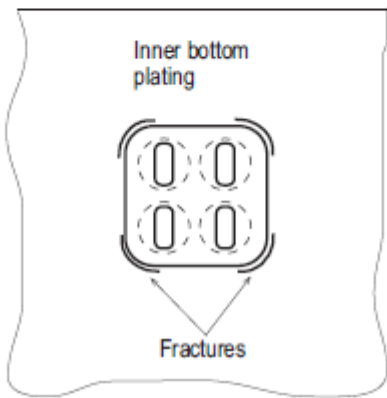
CONTAINER SHIPS		Guidelines for Surveys, Assessment and Repair of Hull Structures	
PART 1	Cargo hold region	EXAMPLE No.	
AREA 4	Double bottom tank structure	1	
Detail of damage		Fractures in inner bottom plating around container bottom pocket	
<p>Sketch of damage</p>

<p>Notes on possible cause of damage</p> <p>1. Pocket is not supported correctly by floor, longitudinal and/or stiffener.</p>		<p>Notes on repairs</p> <p>1. Fractured plating should be cropped and part renewed.</p> <p>2. Adequate reinforcement should be considered.</p>

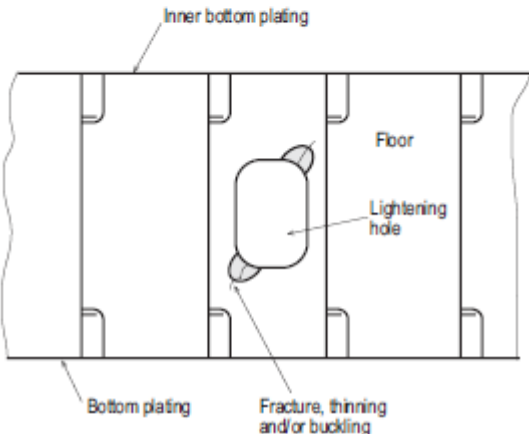
CONTAINER SHIPS		Guidelines for Surveys, Assessment and Repair of Hull Structures	
PART 1	Cargo hold region	EXAMPLE No.	
AREA 4	Double bottom tank structure	2	
Detail of damage		Fractures, corrosion and/or buckling of floor/girder around lightening hole	
<p>Sketch of damage</p>

<p>Notes on possible cause of damage</p> <ol style="list-style-type: none"> 1. Insufficient strength due to lightening hole. 2. Fracture, corrosion and/or buckling around lightening hole due to high stress. 		<p>Notes on repairs</p> <ol style="list-style-type: none"> 1. Fractured, corroded and/or buckled plating should be cropped and renewed if considered necessary. 2. Appropriate reinforcement should be considered.

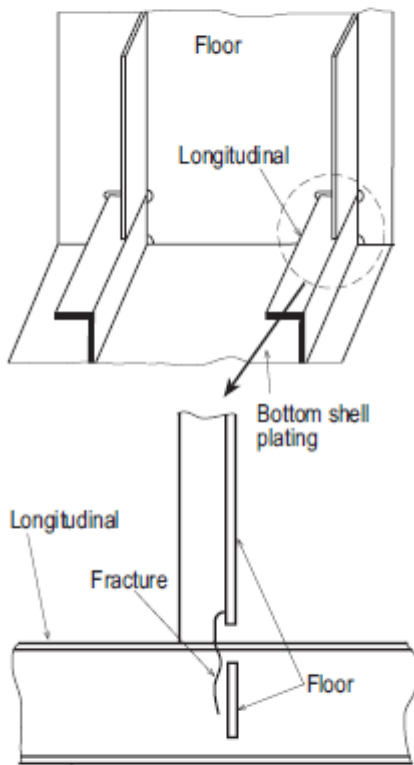
CONTAINER SHIPS		Guidelines for Surveys, Assessment and Repair of Hull Structures	
PART 1	Cargo hold region		EXAMPLE No.
AREA 4	Double bottom tank structure		3
Detail of damage		Fractures in longitudinal at floor or bulkhead	
<p>Sketch of damage</p>

<p>Note: Same damage may occur at similar connection to inner bottom plating</p>		<p>Sketch of repair</p>

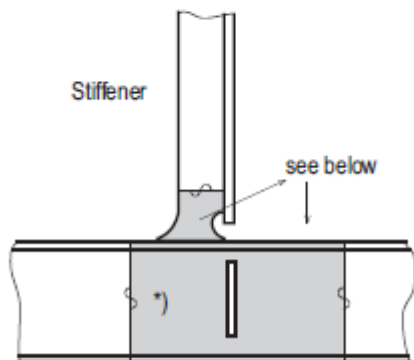
<p>*) Where required, the longitudinal to be cropped and part renewed</p>

<p>Various cut-out shapes have been developed. The following is one example.</p> <ol style="list-style-type: none"> 1. Toe height as small as possible ($h = 10 - 15 \text{ mm}$) 2. Depth "d" of key hole notch as small as possible, max. 30 mm 3. For a slope at toe max. 1 : 3: $R1 = 1.5 d$ $R2 = d$ and $R3 = 1.5 c$ 	
<p>Notes on possible cause of damage</p> <p>1. Damage can be caused by stress concentrations leading to accelerated fatigue in this region.</p>		<p>Notes on repairs</p> <p>1. If fracture extends to over one third of the depth of the longitudinal, then crop and part renew. Otherwise the fracture can be veed-out and welded.</p>

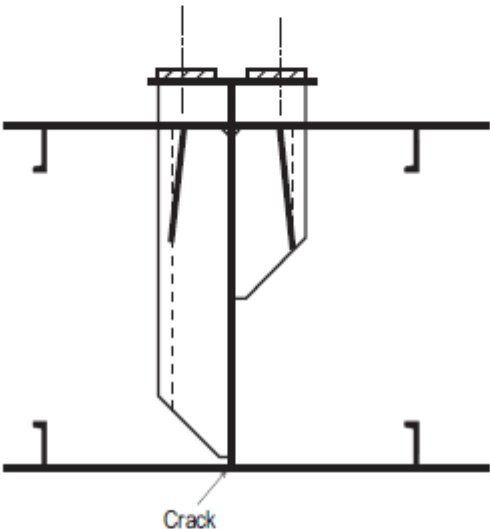
CONTAINER SHIPS		Guidelines for Surveys, Assessment and Repair of Hull Structures	
PART 1	Cargo hold region		EXAMPLE No.
AREA 4	Double bottom tank structure		4
Detail of damage		Fractures in longitudinal girders in way of container support	
<p>Sketch of damage</p>

<p>Notes on possible cause of damage</p> <p>1. Damage can be caused by an insufficient strength of the longitudinal girder at the termination of the vertical stiffeners. The effect of a simultaneous occurrence of the tank pressure from one side and an asymmetrical load from the container sockets has not been taken into account.</p>		<p>Notes on repairs</p> <p>1. Fractured part of the longitudinal girder has to be cropped and renewed by an insert.</p> <p>2. The lower part of the girder has to be supported by an additional transverse stiffener on the bottom shell plating.</p>

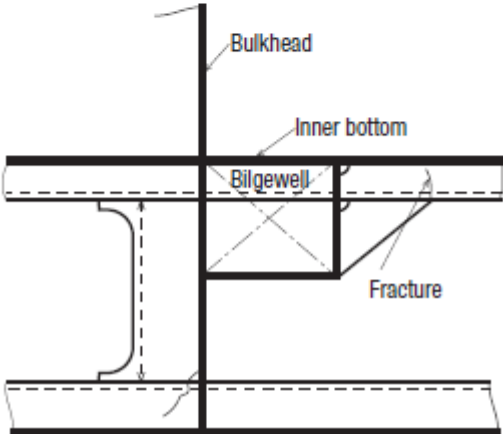
CONTAINER SHIPS		Guidelines for Surveys, Assessment and Repair of Hull Structures	
PART 1	Cargo hold region		EXAMPLE No.
AREA 4	Double bottom tank structure		5
Detail of damage		Fractures in longitudinal in way of bilge well	
<p>Sketch of damage</p>

<p>*) : Where required the longitudinals to be cropped and part renewed</p>	
<p>Notes on possible cause of damage</p> <ol style="list-style-type: none"> 1. Damage can be caused by stress concentrations leading to accelerated fatigue in this region. 		<p>Notes on repairs</p> <ol style="list-style-type: none"> 1. If fractures are not extensive e.g. hairline fractures then these can be vee-d-out and welded. 2. If the fracture has extended to over one third of the depth of the longitudinal then crop and part renew.

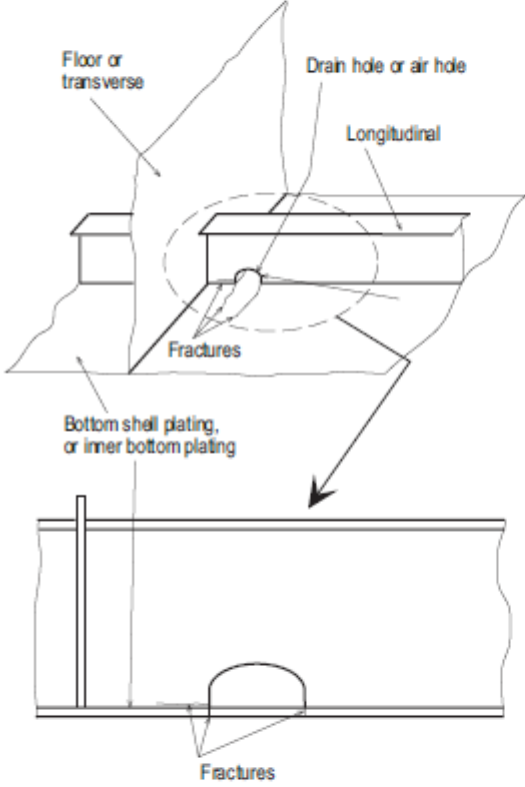
CONTAINER SHIPS		Guidelines for Surveys, Assessment and Repair of Hull Structures	
PART 1	Cargo hold region		EXAMPLE No.
AREA 4	Double bottom tank structure		6
Detail of damage		Fractures in bottom shell or inner bottom plating at the corner drain hole/air hole in longitudinal	
<p>Sketch of damage</p>

<p>Notes on possible cause of damage</p> <ol style="list-style-type: none"> 1. Stress concentration and/or corrosion due to stress concentration at the corner of drain hole/air hole. 		<p>Notes on repairs</p> <ol style="list-style-type: none"> 1. Fractured plating should be cropped and part renewed. 2. If fatigue life is to be improved, change of drain hole/air hole shape is to be considered.

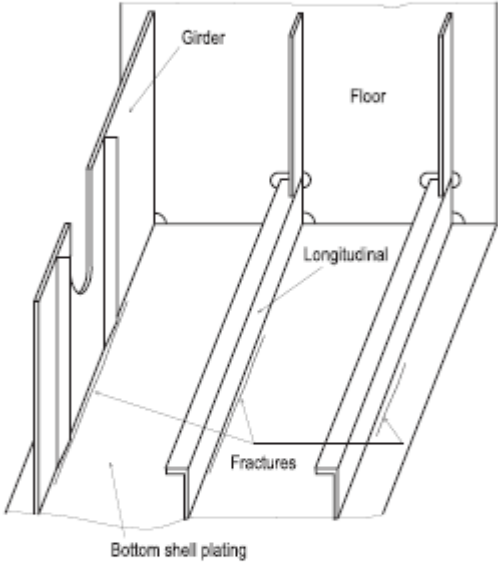
CONTAINER SHIPS		Guidelines for Surveys, Assessment and Repair of Hull Structures	
PART 1	Cargo hold region		EXAMPLE No.
AREA 4	Double bottom tank structure		7
Detail of damage		Fractures in bottom plating alongside girder and/or bottom longitudinal	
<p>Sketch of damage</p>

<p>Notes on possible cause of damage</p> <p>1. Vibration.</p>		<p>Notes on repairs</p> <p>1. Fractured bottom shell plating should be cropped and renewed.</p> <p>2. Natural frequency of the panel should be changed, e.g. reinforcement by additional stiffener/bracket.</p>

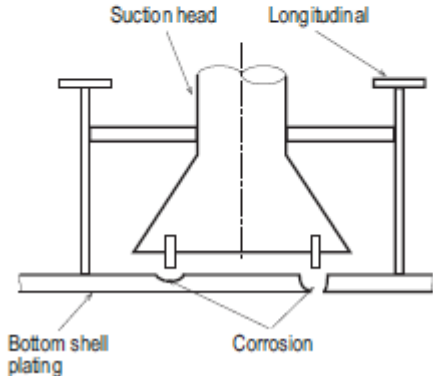
CONTAINER SHIPS		Guidelines for Surveys, Assessment and Repair of Hull Structures	
PART 1	Cargo hold region	EXAMPLE No.	
AREA 4	Double bottom tank structure	8	
Detail of damage		Corrosion in bottom plating below suction head	
<p>Sketch of damage</p>

<ol style="list-style-type: none"> 1. Insert to have round corners 2. Non-destructive examination to be applied after welding based on the Classification Society's rules 	
<p>Notes on possible cause of damage</p> <ol style="list-style-type: none"> 1. High flow rate associated with insufficient corrosion prevention system. 2. Galvanic action between dissimilar metals. 		<p>Notes on repairs</p> <ol style="list-style-type: none"> 1. Affected plating should be cropped and part renewed. Thicker plate and suitable beveling should be considered. 2. If the corrosion is limited to a small area, i. e. pitting corrosion, repair by welding is acceptable.

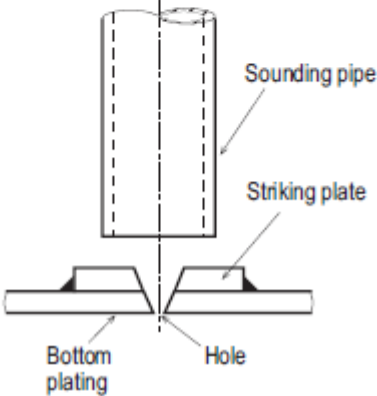
CONTAINER SHIPS		Guidelines for Surveys, Assessment and Repair of Hull Structures	
PART 1	Cargo hold region		EXAMPLE No.
AREA 4	Double bottom tank structures		9
Detail of damage		Corrosion in bottom plating below sounding pipe	
<p>Sketch of damage</p>

<p>Notes on possible cause of damage</p> <p>1. Accelerated corrosion of striking plate by the striking of the weight of the sounding tape.</p>		<p>Notes on repairs</p> <p>1. Corroded bottom plating should be welded or partly cropped and renewed if considered necessary.</p> <p>2. Corroded striking plate should be renewed.</p>

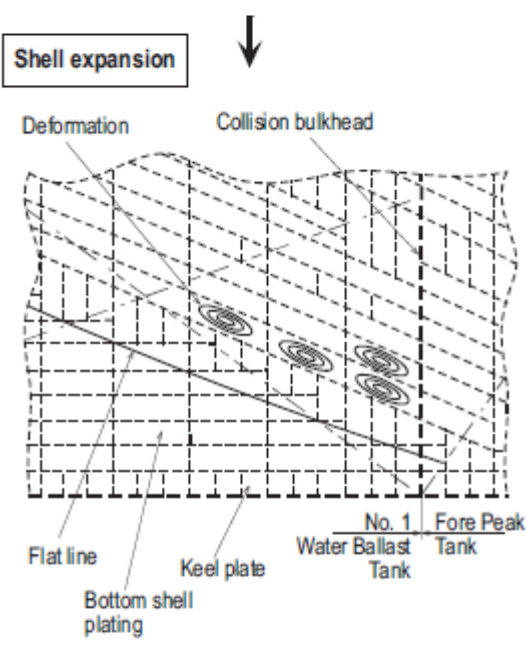
CONTAINER SHIPS		Guidelines for Surveys, Assessment and Repair of Hull Structures	
PART 1	Cargo hold region		EXAMPLE No.
AREA 4	Double bottom tank structure		10
Detail of damage		Deformation of forward bottom shell plate due to slamming	
<p>Sketch of damage</p>

<p>Notes on possible cause of damage</p> <ol style="list-style-type: none"> 1. Heavy weather. 2. Poor design for slamming. 3. Poor operation, i.e. negligence of heavy ballast. 		<p>Notes on repairs</p> <ol style="list-style-type: none"> 1. Deformed bottom shell plating should be faired in place, or partly cropped and renewed if considered necessary. 2. Bottom shell plating should be reinforced by stiffeners.

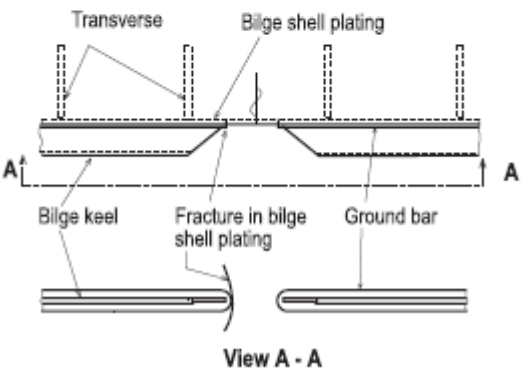
CONTAINER SHIPS		Guidelines for Surveys, Assessment and Repair of Hull Structures	
PART 1	Cargo hold region		EXAMPLE No.
AREA 4	Double bottom tank structure		11
Detail of damage		Fractures in shell plating at the termination of bilge keel	
<p>Sketch of damage</p>

<p>Notes on possible cause of damage</p> <p>1. Poor design causing stress concentration.</p>		<p>Notes on repairs</p> <p>1. Fractured plating is to be cropped and renewed.</p> <p>2. Reduction of stress concentration of the bilge keel end should be considered.</p> <p>Repair A: Modification of the detail of end</p> <p>Repair B: New internal stiffeners</p> <p>Repair C: Continuous ground bar (in connection with Repair A)</p> <p>3. Instead of Repair A or B continuous ground bar and bilge keel should be considered.</p>

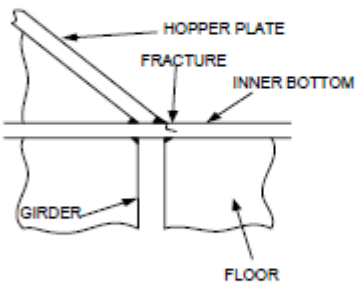
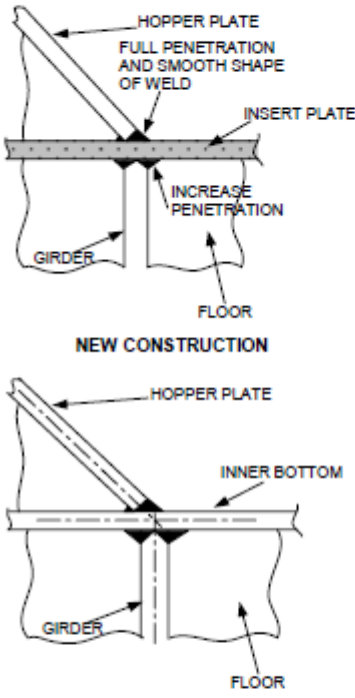
OIL Tankers		Guidelines for Surveys, Assessment and Repair of Hull Structure
Group 1	Cargo area	Example No.
	Hopper and double bottom ballast tank	1
Detail of damage	Fracture on the inner bottom plating at the connection of hopper plate to inner bottom	
Sketch of damage		Sketch of repair

<p>Notes: Plate midlines intersect</p>
Factors which may have caused damage <ol style="list-style-type: none"> 1. Stress concentration at juncture of hopper plate to inner bottom. 2. Insufficient welding connection. 3. Misalignment between hopper plate, inner bottom and girder. 		Notes on repairs See Sketch.

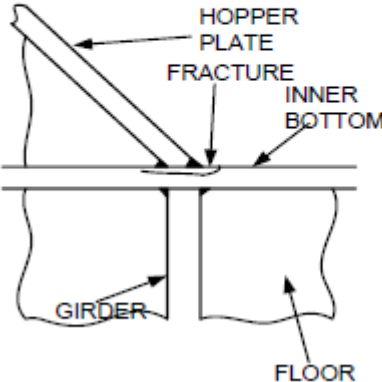
OIL Tankers		Guidelines for Surveys, Assessment and Repair of Hull Structure	
Group 1	Cargo area	Example No.	
	Hopper and double bottom ballast tank	2	
Detail of damage		Fracture at connection of bilge hopper plate and inner bottom	
Sketch of damage

<p>Notes: Plate midlines intersect</p>	
Factors which may have caused damage 1. Stress concentration at the knuckle.		Notes on repairs See Sketch.

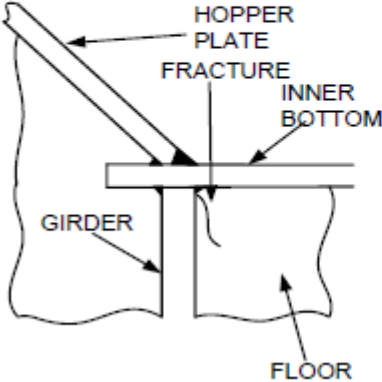
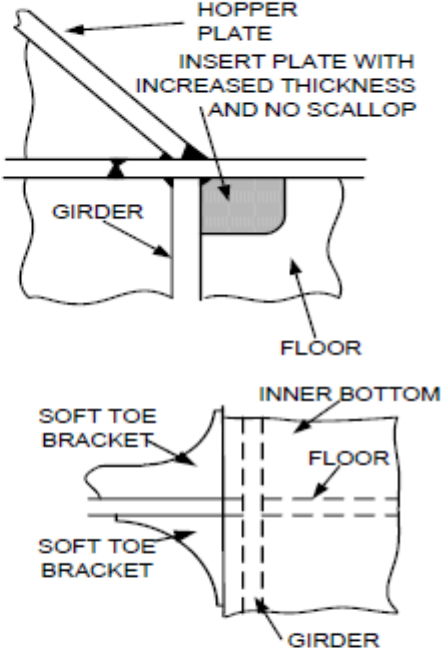
OIL Tankers		Guidelines for Surveys, Assessment and Repair of Hull Structure
Group 1	Cargo area	Example No.
	Hopper and double bottom ballast tank	3
Detail of damage	Fracture at connection of bilge hopper plate and inner bottom	
Sketch of damage		Sketch of repair

<p>Notes: Plate midlines intersect</p>
Factors which may have caused damage 1. Stress concentration at the knuckle.		Notes on repairs See Sketch.

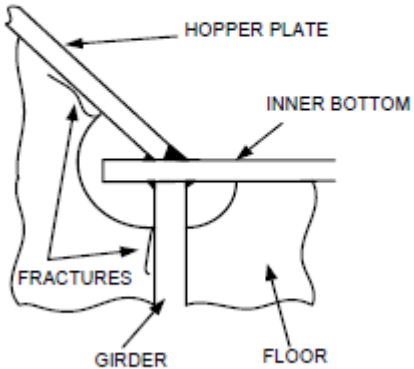
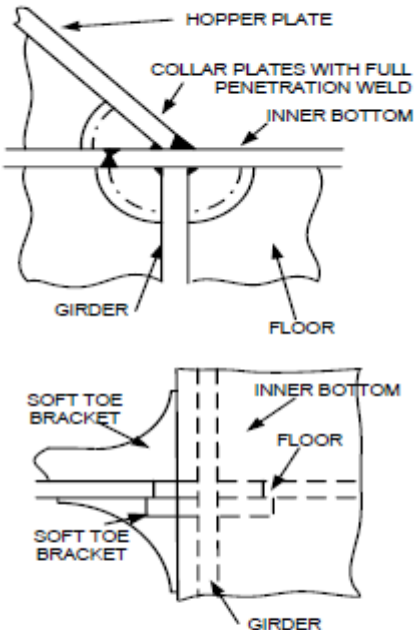
OIL Tankers		Guidelines for Surveys, Assessment and Repair of Hull Structure
Group 1	Cargo area	Example No.
	Hopper and double bottom ballast tank	4
Detail of damage		Fracture at connection of bilge hopper plate and inner bottom
Sketch of damage		Sketch of repair

<p>Notes: Plate midlines intersect</p>
Factors which may have caused damage 1. Stress concentration at the knuckle.		Notes on repairs See Sketch.

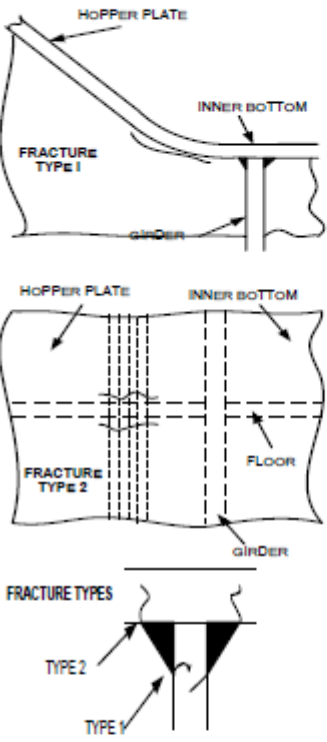
OIL Tankers		Guidelines for Surveys, Assessment and Repair of Hull Structure
Group 1	Cargo area	Example No.
	Hopper and double bottom ballast tank	5
Detail of damage		Fractured floor and inner bottom plate in way of juncture of inner bottom to hopper plate
Sketch of damage		Sketch of repair

<p>Sketch of damage showing Fracture Type 1 and Fracture Type 2. Fracture Type 1 shows a hopper plate, inner bottom, and girder with a fracture at the junction. Fracture Type 2 shows a hopper plate, inner bottom, floor, and girder with a fracture at the junction. A legend shows Fracture Type 1 as a V-shape and Fracture Type 2 as a U-shape.</p>

Factors which may have caused damage <ol style="list-style-type: none"> 1. Misalignment. The three mid-lines do not cross at the same joint. This misalignment produces an out-of-plane deformation of inner bottom plate in way of knuckle line. 2. Stress concentration at connection between floor and inner bottom plate. 3. Static and dynamic load of ballast water. 		Notes on repairs See Sketch.

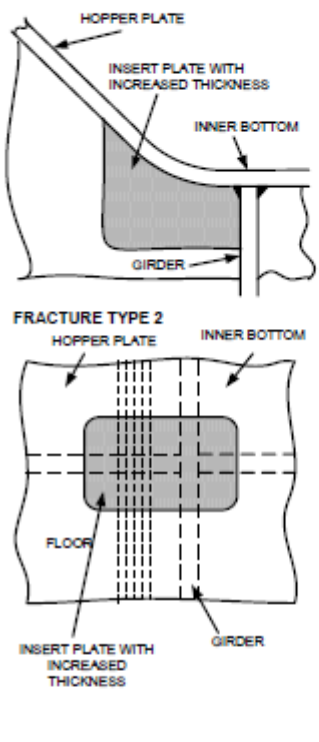
<p>Sketch of repair showing Fracture Type 1 and Fracture Type 2. Fracture Type 1 shows a hopper plate, inner bottom, and girder with an insert plate with increased thickness at the junction. Fracture Type 2 shows a hopper plate, inner bottom, floor, and girder with an insert plate with increased thickness at the junction.</p>

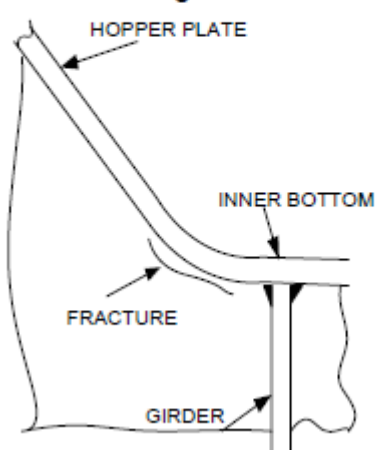
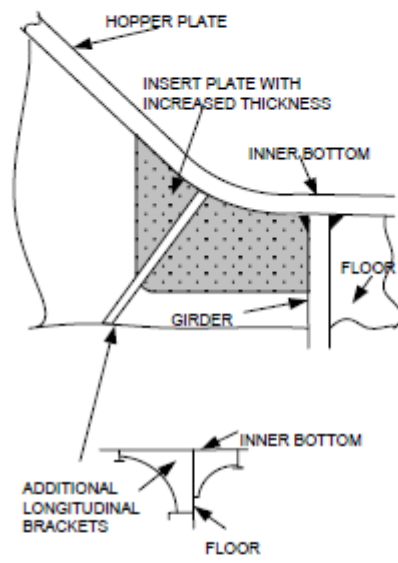
OIL Tankers		Guidelines for Surveys, Assessment and Repair of Hull Structure
Group 1	Cargo area	Example No.
	Hopper and double bottom ballast tank	6
Detail of damage	Fracture at connection of bilge hopper plate and web frame	
Sketch of damage		Sketch of repair

Factors which may have caused damage 1. Stress concentration due to reduction of effective flange area at curved plate.		Notes on repairs See Sketch.

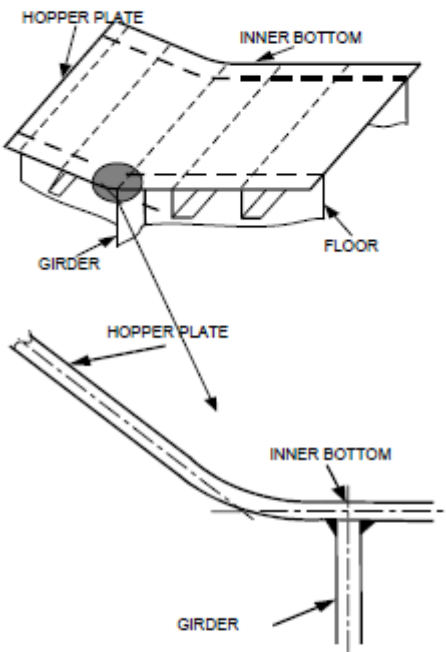
OIL Tankers		Guidelines for Surveys, Assessment and Repair of Hull Structure
Group 1	Cargo area	Example No.
	Hopper and double bottom ballast tank	7
Detail of damage	Rounded hopper plate deformation in way of the floor	
Sketch of damage

Factors which may have caused damage 1. Misalignment. The three midlines do not cross at the same joint. This misalignment produces an out-of-plane deformation in knuckled plate in the vicinity of floor. 2. Insufficient stiffening between floors.		Notes on repairs See Sketch.

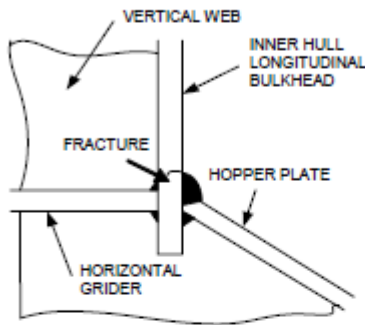
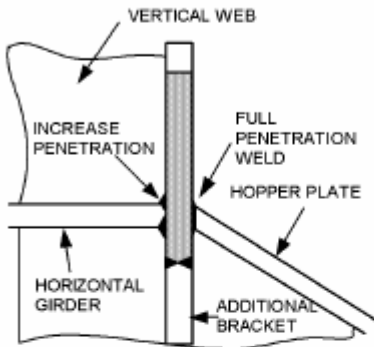
OIL Tankers		Guidelines for Surveys, Assessment and Repair of Hull Structure	
Group 1	Cargo area	Example No.	
	Wing cargo tank	8	
Detail of damage	Fracture at the connection of hopper plate to outside longitudinal bulkhead.		
Sketch of damage		Sketch of repair

Factors which may have caused damage		Notes on repairs	
<ol style="list-style-type: none">1. Stress concentration at junction of hopper plate to outside longitudinal bulkhead.2. Insufficient welding connection and/or incorrect shape of the weld toe.3. Misalignment between hopper plate, outside longitudinal bulkhead and side stringer.		See Sketch.

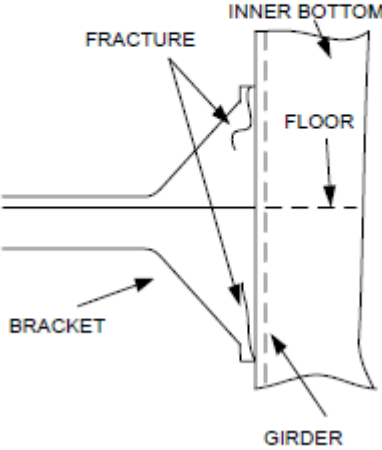
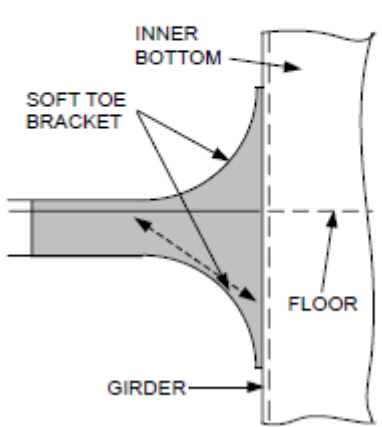
OIL Tankers		Guidelines for Surveys, Assessment and Repair of Hull Structure	
Group 1	Cargo area	Example No.	
	Hopper and double bottom ballast tank	9	
Detail of damage		Fracture in gusset plate in line with inner bottom	
Sketch of damage		Sketch of repair

<p>Notes: Bracket radii as large as practicable. Bracket same thickness as inner bottom stiffener. Toe height should be small as possible while still allowing return weld (wrapped weld).</p>	
Factors which may have caused damage <ol style="list-style-type: none"> 1. Stress concentration due to small radius and abrupt toe. 2. Insufficient welding. 3. Insufficient sectional area (thickness x breadth) of the connecting bracket. 		Notes on repairs See Sketch.

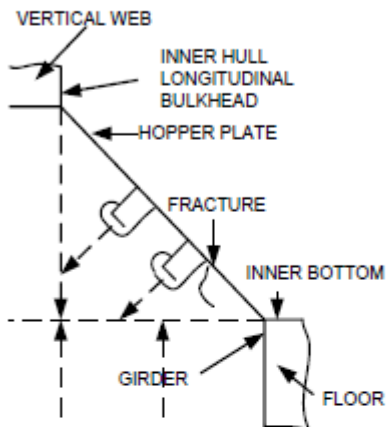
OIL Tankers		Guidelines for Surveys, Assessment and Repair of Hull Structure
Group 1	Cargo area	Example No.
	Hopper ballast tank	10
Detail of damage	Fracture in way of cut-out in hopper plate	
Sketch of damage

Factors which may have caused damage 1. Stress concentration due to no collar plate.		Notes on repairs See Sketch.

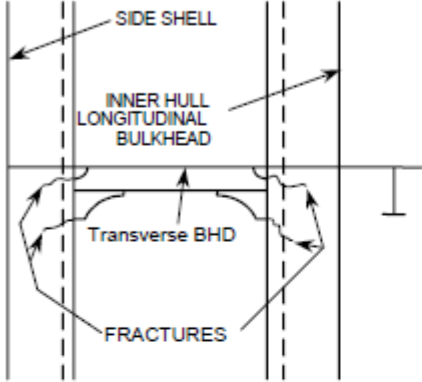
<p>Sketch of damage</p> </div> <div style="text-align: center;">

OIL Tankers		Guidelines for Surveys, Assessment and Repair of Hull Structure
Group 2	Cargo area	Example No.
	Wing ballast tank	1
Detail of damage	Crack in way of connection of longitudinals to transverse bulkhead	
Sketch of damage	<div style="display: flex; justify-content: space-around;"> <div style="text-align: center;">

<p>Sketch of repair</p> </div> </div>	
Factors which may have caused damage	<p>Notes on repairs See Sketch.</p> <ol style="list-style-type: none"> 1. Asymmetrical connection of bracket without backing bracket. 2. Relative deflection of adjoining transverse web against transverse bulkhead. 3. Additional biaxial bending stresses due to asymmetry of the angle bar longitudinal instead of symmetric T section. 4. Dynamic load in the vicinity of the water line. 5. Large upstand at bracket toe.

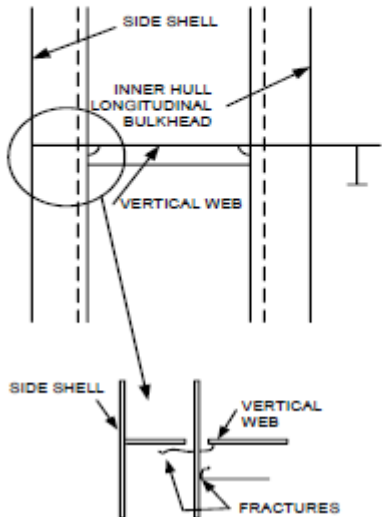
OIL Tankers		Guidelines for Surveys, Assessment and Repair of Hull Structure	
Group 2	Cargo area	Example No.	
	Wing ballast tank	2	
Detail of damage		Crack in way of connection of longitudinals to transverse webs	
Sketch of damage

Factors which may have caused damage <ol style="list-style-type: none"> 1. Asymmetrical connection of flat bar stiffener resulting in high peak stresses at the heel of the stiffener. 2. Insufficient area of connection of longitudinal to web. 3. High bending stresses in the longitudinal. 4. Additional biaxial bending stresses due to asymmetry of the longitudinal (angle bar instead of symmetric T bar). 5. Stress concentration at the square angles at heel and toe of the connections. 6. High shear stress in the transverse web. 		Notes on repairs See Sketch.

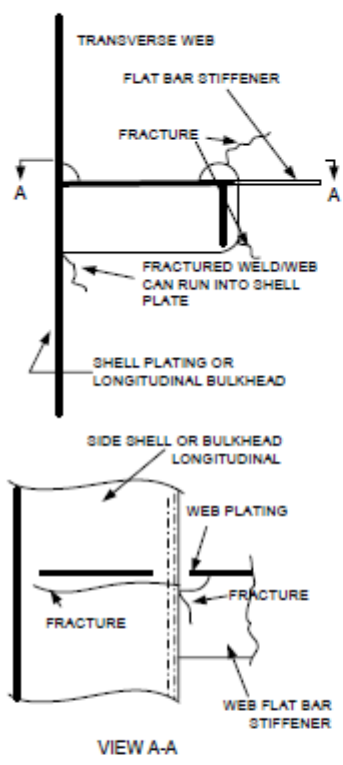
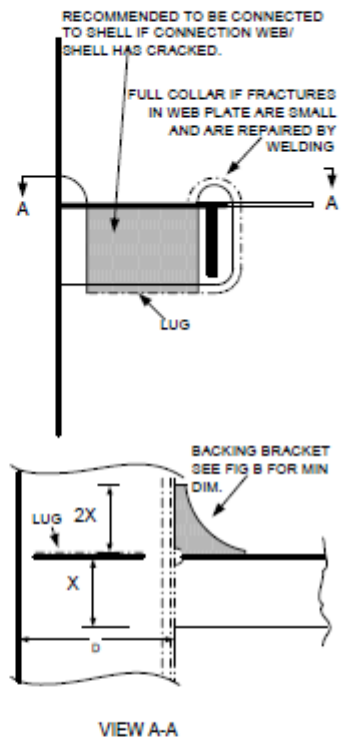
OIL Tankers		Guidelines for Surveys, Assessment and Repair of Hull Structure
Group 2	Cargo area	Example No.
	Wing ballast tank	3
Detail of damage	Fracture in way of web and flat bar stiffener at cut outs for longitudinal stiffener connections.	
Sketch of damage		Sketch of repair

<p>Insert longitudinal.</p>
Factors which may have caused damage <ol style="list-style-type: none"> 1. Asymmetrical connection of flat bar stiffener resulting in high peak stress at heel of the stiffener under fatigue loading. 2. Insufficient area of connection of longitudinal to web plate. 3. Defective weld at return around the plate thickness. 4. High localized corrosion at areas of stress concentrations such as flat bar stiffener connections, corners of cut out for longitudinal and connection of web to shell at cut outs. 5. High shear stress in web of the transverse. 6. Dynamic seaway loads/motions. 		Notes on repairs See Sketch. May also fit a double bracket to avoid fracture from toe.

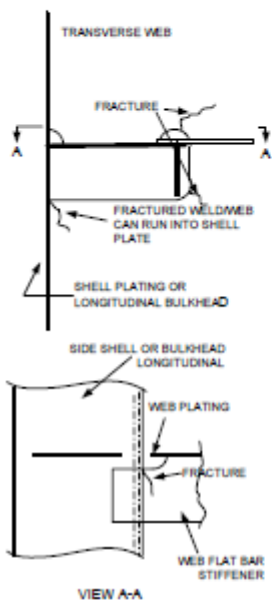
OIL Tankers		Guidelines for Surveys, Assessment and Repair of Hull Structure
Group 2	Cargo area	Example No.
	Wing ballast tank	4
Detail of damage	Fracture in way of web and flat bar stiffener at cut outs for longitudinal stiffener connections as Example 3 but with faceplate attached to underside of web. Flat bar lap welded.	
Sketch of damage

<p>Insert web plate.</p>	
Factors which may have caused damage	<ol style="list-style-type: none"> 1. Asymmetrical connection of flat bar stiffener resulting in high peak stress at heel of the stiffener under fatigue loading. 2. Fabricated longitudinal with welding onto exposed edge of the web resulting in poor fatigue strength of the connection of the longitudinal to the flat bar. 3. Insufficient area of connection of longitudinal to web plate. 4. Defective weld at return around the plate thickness. 5. High localized corrosion at areas of stress concentrations such as flat bar stiffener connections, corners of cut out for longitudinal and connection of lug to shell at cut outs. 6. High shear stress in web of the transverse. 7. Dynamic seaway loads/motions.

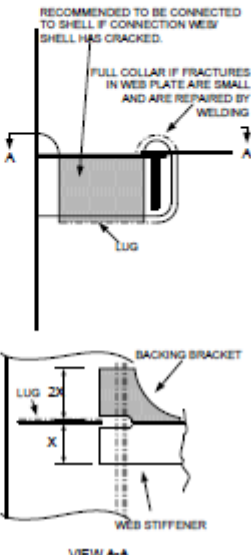
Sketch of repair

Notes on repairs	<p>See Sketch.</p> <ol style="list-style-type: none"> 1. May also fit a double bracket to avoid fracture from toe.

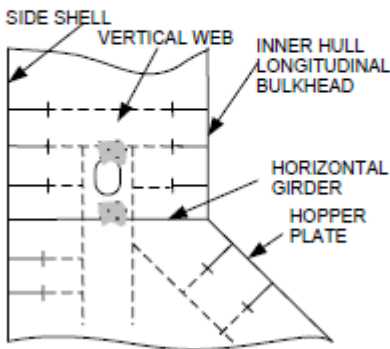
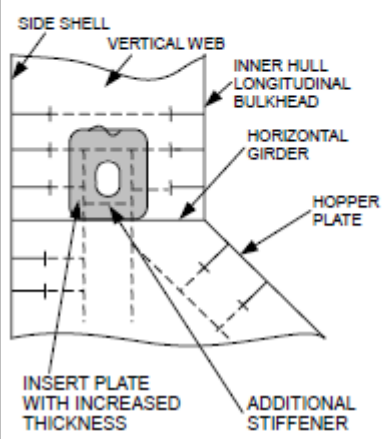
OIL Tankers		Guidelines for Surveys, Assessment and Repair of Hull Structure
Group 2	Cargo area	Example No. 5
	Wing ballast tank	
Detail of damage		Buckling in way of side web panels above hopper horizontal girder
Sketch of damage		Sketch of repair

Factors which may have caused damage 1. High shear stress in the transverse web. 2. Insufficient buckling strength.		Notes on repairs See Sketch.
